## Near Miss: Personnel nearly struck by rotating chain attached to flexible pipe

Safety Flash Published on 20 April 2023 Generated on 7 May 2025 IMCA SF 10/23

Crew were involved in the second end transfer of a 4" (10cm) production flexible up to the top module of the pipelay system.

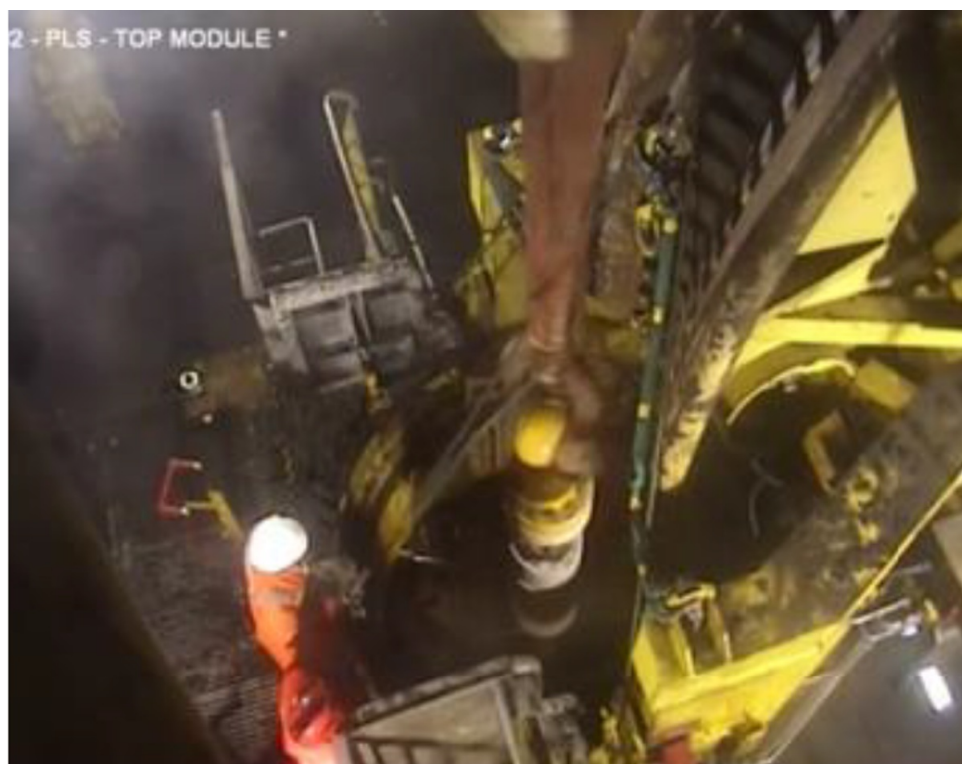
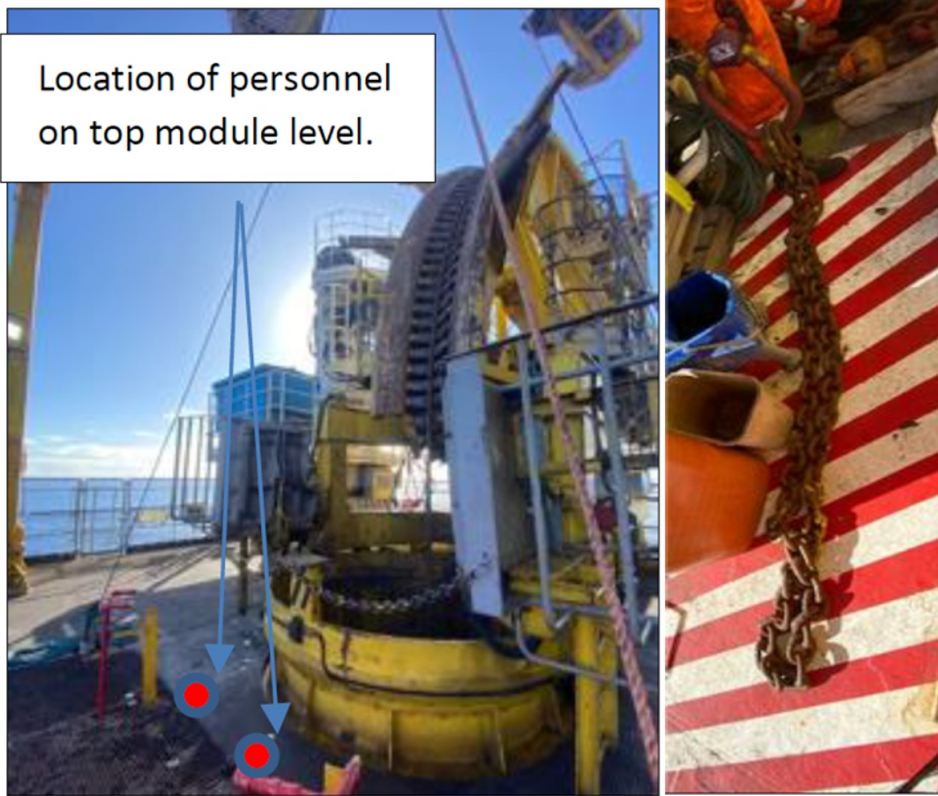
This then resulted in the production flexible rotating due to the residual torsion that had been built up within the line.

A 16.5te chain used for the transfer of the second end was still attached to the pull-in head, as the flexible pipe began to rotate, this chain also spun.

Two crew members who were observing the operation were stood nearby and were almost struck by the spinning chain.

- Key people involved were inexperienced in this specific activity and were not familiar with the task in hand
- There was a failure to identify the risk posed from the chain still being attached to the flexible pipe.
- There was a language barrier:
  - Some of the team were unable to speak English.
  - The Task Risk Assessment for this operation was only available in English.
- The procedure did not identify when the chain should be removed nor other mitigation measures.

- Ensure important documentation such as Task Risk Assessment, procedures and checklists are available in the languages of the crew doing the work.
- Ensure it is specified in procedures or checklists when rigging or any other items are to be attached or removed.
- Always remove the rigging after transferring loads to the A&R; when removal of rigging is not possible, suggest additional mitigation actions in the Task Risk Assessment.

- One mitigating measure was to install a gate with signage restricting access to the top module.
